Report on Howell Cheney Technical High School

Concrete Inspection

Date: June 27, 2023

Location: 791 Middle Turnpike West, Manchester, CT 06040

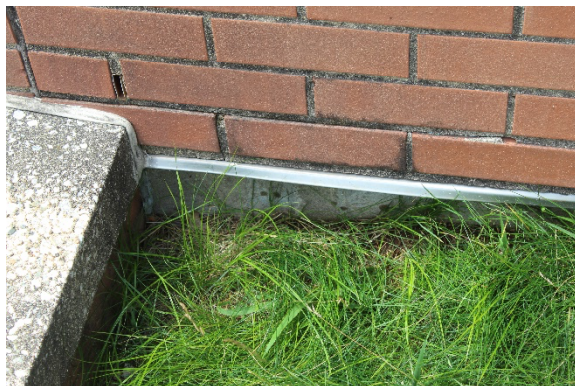
At first glance the horizontal cracking and surface spalling could resemble the appearance of pyrrhotite laden concrete from that period, yet the damaged area was isolated to the short section of the wall in contact with the sidewalk, an area exposed to constant deicing chemicals over the past 14 years. The remainder of the three-sided addition showed no signs of concrete surface defects outside the normal hardened shrinkage cracks which were very small and infrequent.
