Understanding the Effects of Pyrrhotite in Concrete

By Kevin E Miller

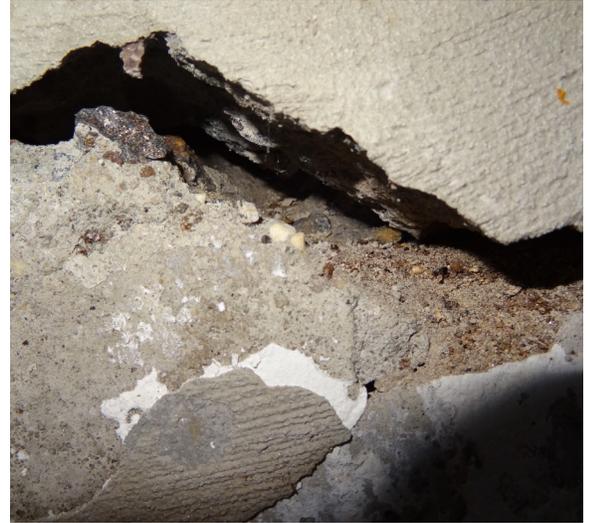
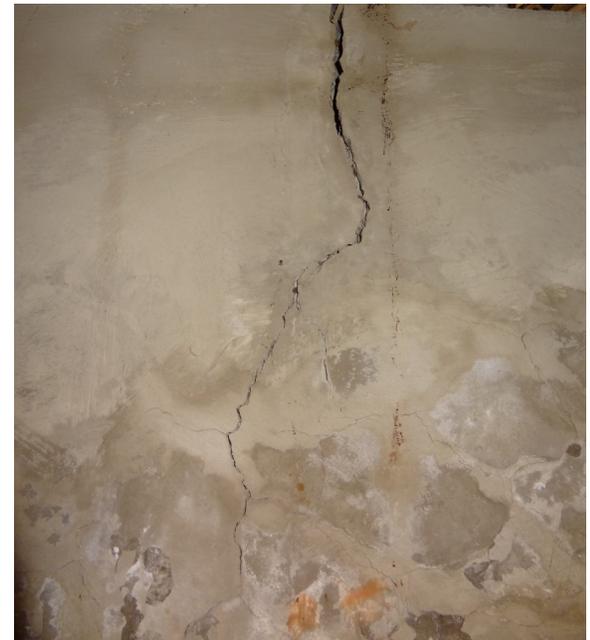
While signs of Pyrrhotite include staining, map cracking, and efflorescence the most damaging aspect is the expansion of a mineral formation known as ettringite contained within the cement resulting in large cracks and inward bulging walls. In many cases the expansion is more severe when plenty of oxygen is available such as above grade and inside the basement spaces.

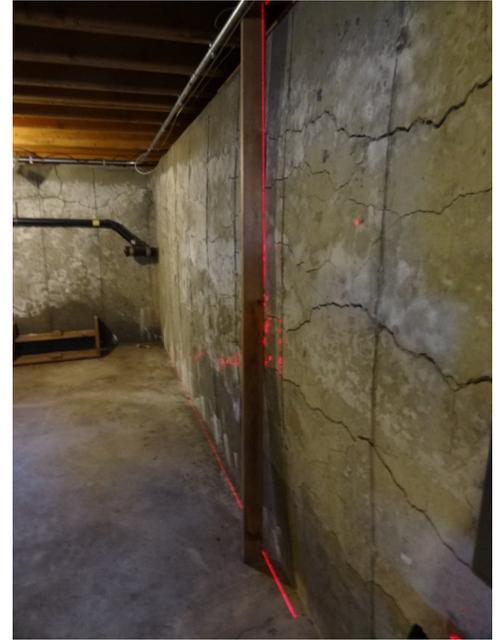
The photo to the right shows the use of a laser to determine the bowing of the wall. Noticeable inward movement of a concrete wall should be viewed by a structural engineer to determine the integrity of the structure.

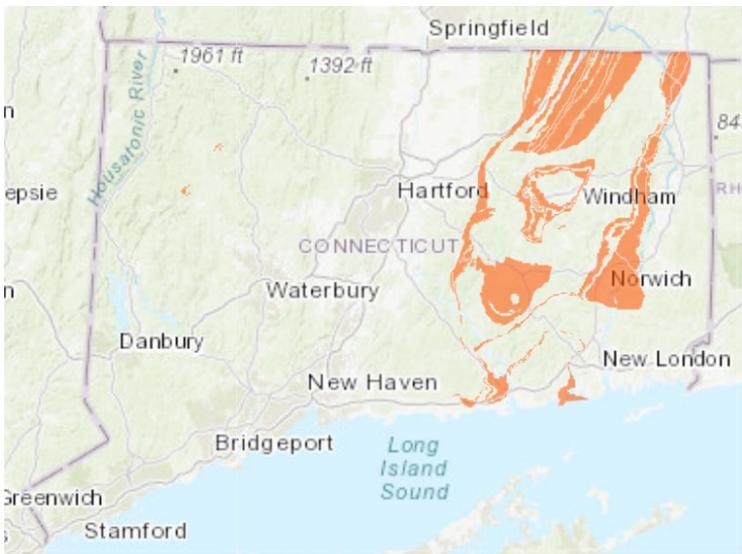
Where is the source of Pyrrhotite? A quarry in West Willington was the source on many of the Connecticut homes. The host aggregate was identified as Brimfield Schist, comprised of interlayered schist and gneiss, and a host of other minerals including garnet, sillimanite, graphite, and pyrrhotite. The map to the left highlights areas in Connecticut containing sulfidic aggregates. The photo below shows the continuance of the path into Massachusetts.

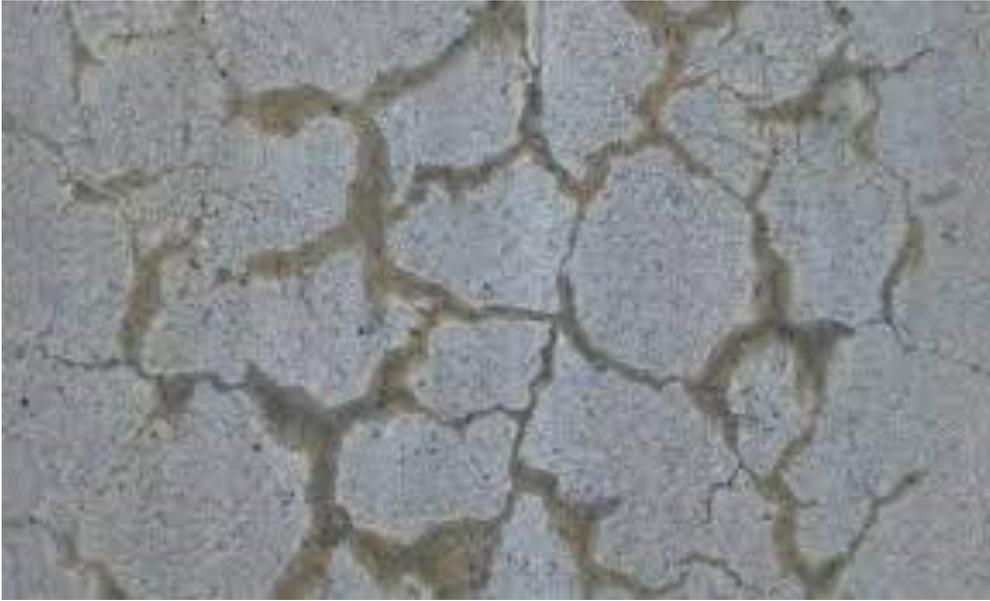
The map cracking as shown in the photo above is caused by a reaction between the cement paste and reactive silica minerals. The alkali hydroxides in the portland cement react with the silica and alkali-silica gel is formed around the aggregate. The gel under certain circumstances when exposed to water will expand and cracking of the concrete will occur. The major differences are, ASR ceases below a relative humidity of 80% and does not exhibit the weakening of the cement paste, as is characteristic of pyrrhotite damaged concrete.
